FIELD INSPECTION

Project Name:	Mountain Valley Pipeline	Inspector:	Matthew Grant
Inspection Date:	Wednesday, October 9, 2019	Project Contact:	Brian Clauto
Spread: Franklin County MP263 St13892+55-13940	Spread I	Weather (Wet/Dry/Rain):	Dry

FIELD INSPECTION PHOTO LOG

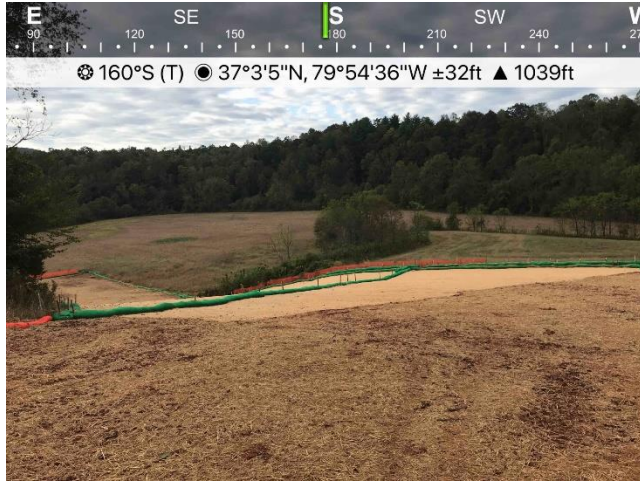
- Fig. 1 Near St13906+79 blanket matting has been installed on slope.

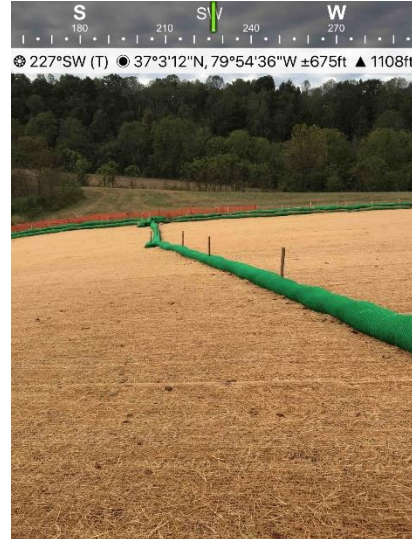
- Fig. 2 Near St13906+79 CFS has been installed across slope.

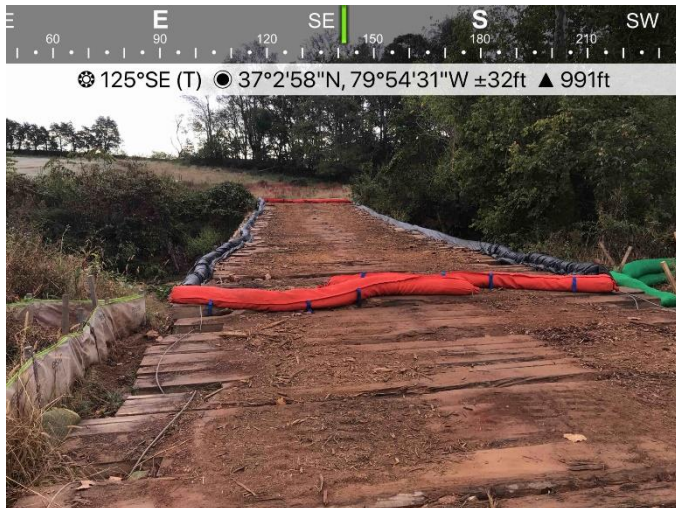
- Fig. 3 At designated stream S-II2, ECD's are in place and functioning.

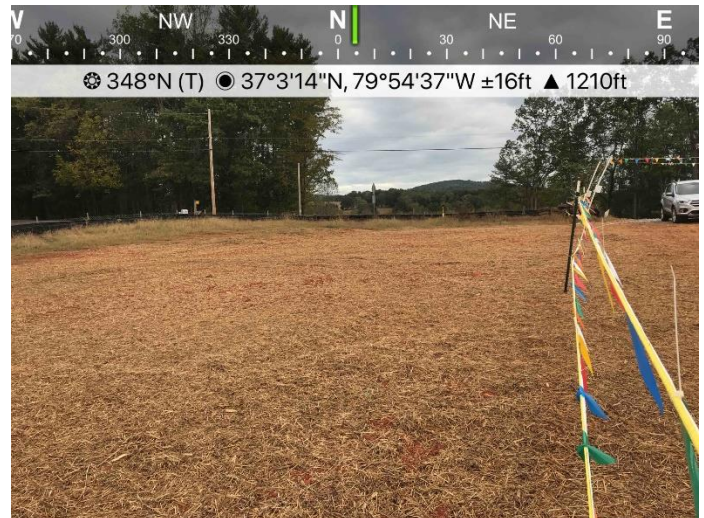
- Fig. 4 Near ATWS 697 are has been stabilized and ECD's are in place and functioning.
